SUMMER 2004

## FRACTOGRAPHY AND FAILURE ANALYSIS

John R. Ambrose, Ph. D., P.E.

### Failure of a PVC Coupling

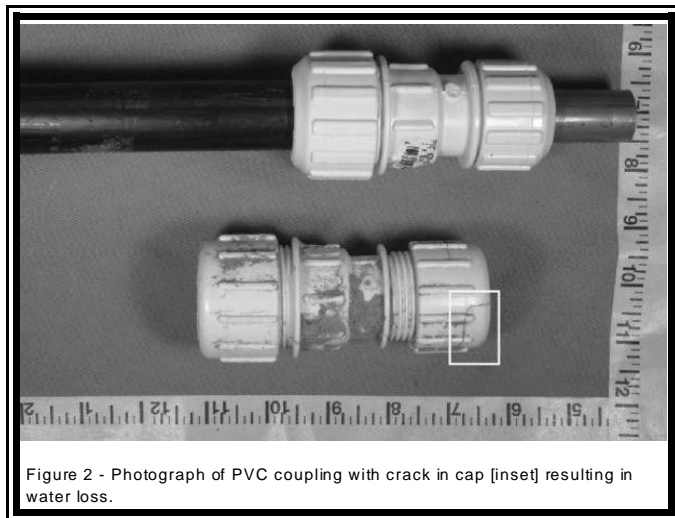
A recent case study involving failure of a plastic coupling joining sections of copper and polyethylene tubing is an excellent illustration of this situation [Figure 2]. The coupling was installed by a subcontractor and failed in about nine months, causing water damage to a residence. Following visual inspection, the origin of the fracture was located at the edge of the opening through which tubing passed.

the circumference of the coupling cap [Figure 2] provided the outlet for the water causing the damage. The crack propagation path followed the hoop stress introduced into the root of the threaded cap during the assembly of the coupling. However, this crack was preceded by the crack which initiated at the hole in the top of the cap, a location which would not normally be under tensile stress - unless the tubing were bent to the degree that sufficient stress were introduced into this region to result in initiation of the fatigue crack leading to final failure. Unless this region were also coincident with the location of the weld line, there can be no causal relationship between the "manufacturing" defect and the failure of the component.

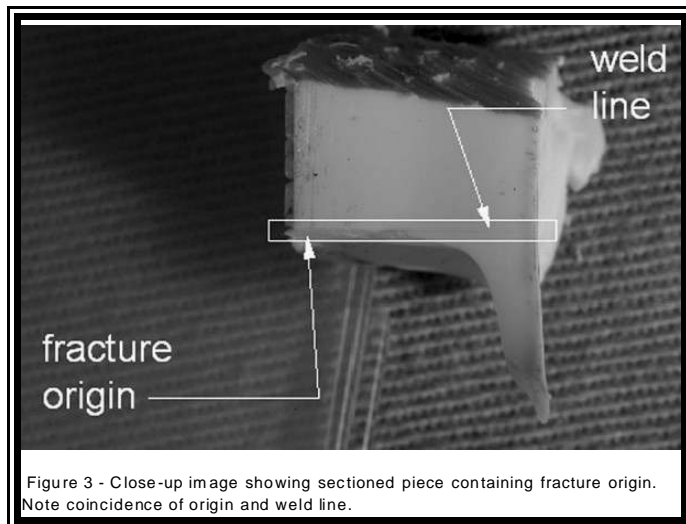
Following notification of the manufacturer, the coupling was sectioned and the fracture origin found to coincide with a weld line [Figure 3]. The crack was found to have propagated over a period of time by a fatigue crack growth process [Figure 4].

The fact that the failure is associated with a material defect [the weld line] does not, by itself, establish causation as being the result of a manufacturing defect. The radial crack extending around
